INDIAN LAKE DAM

(NDI I.D. PA-0057

DER I.D. 058-038)

PHASE I INSPECTION REPORT

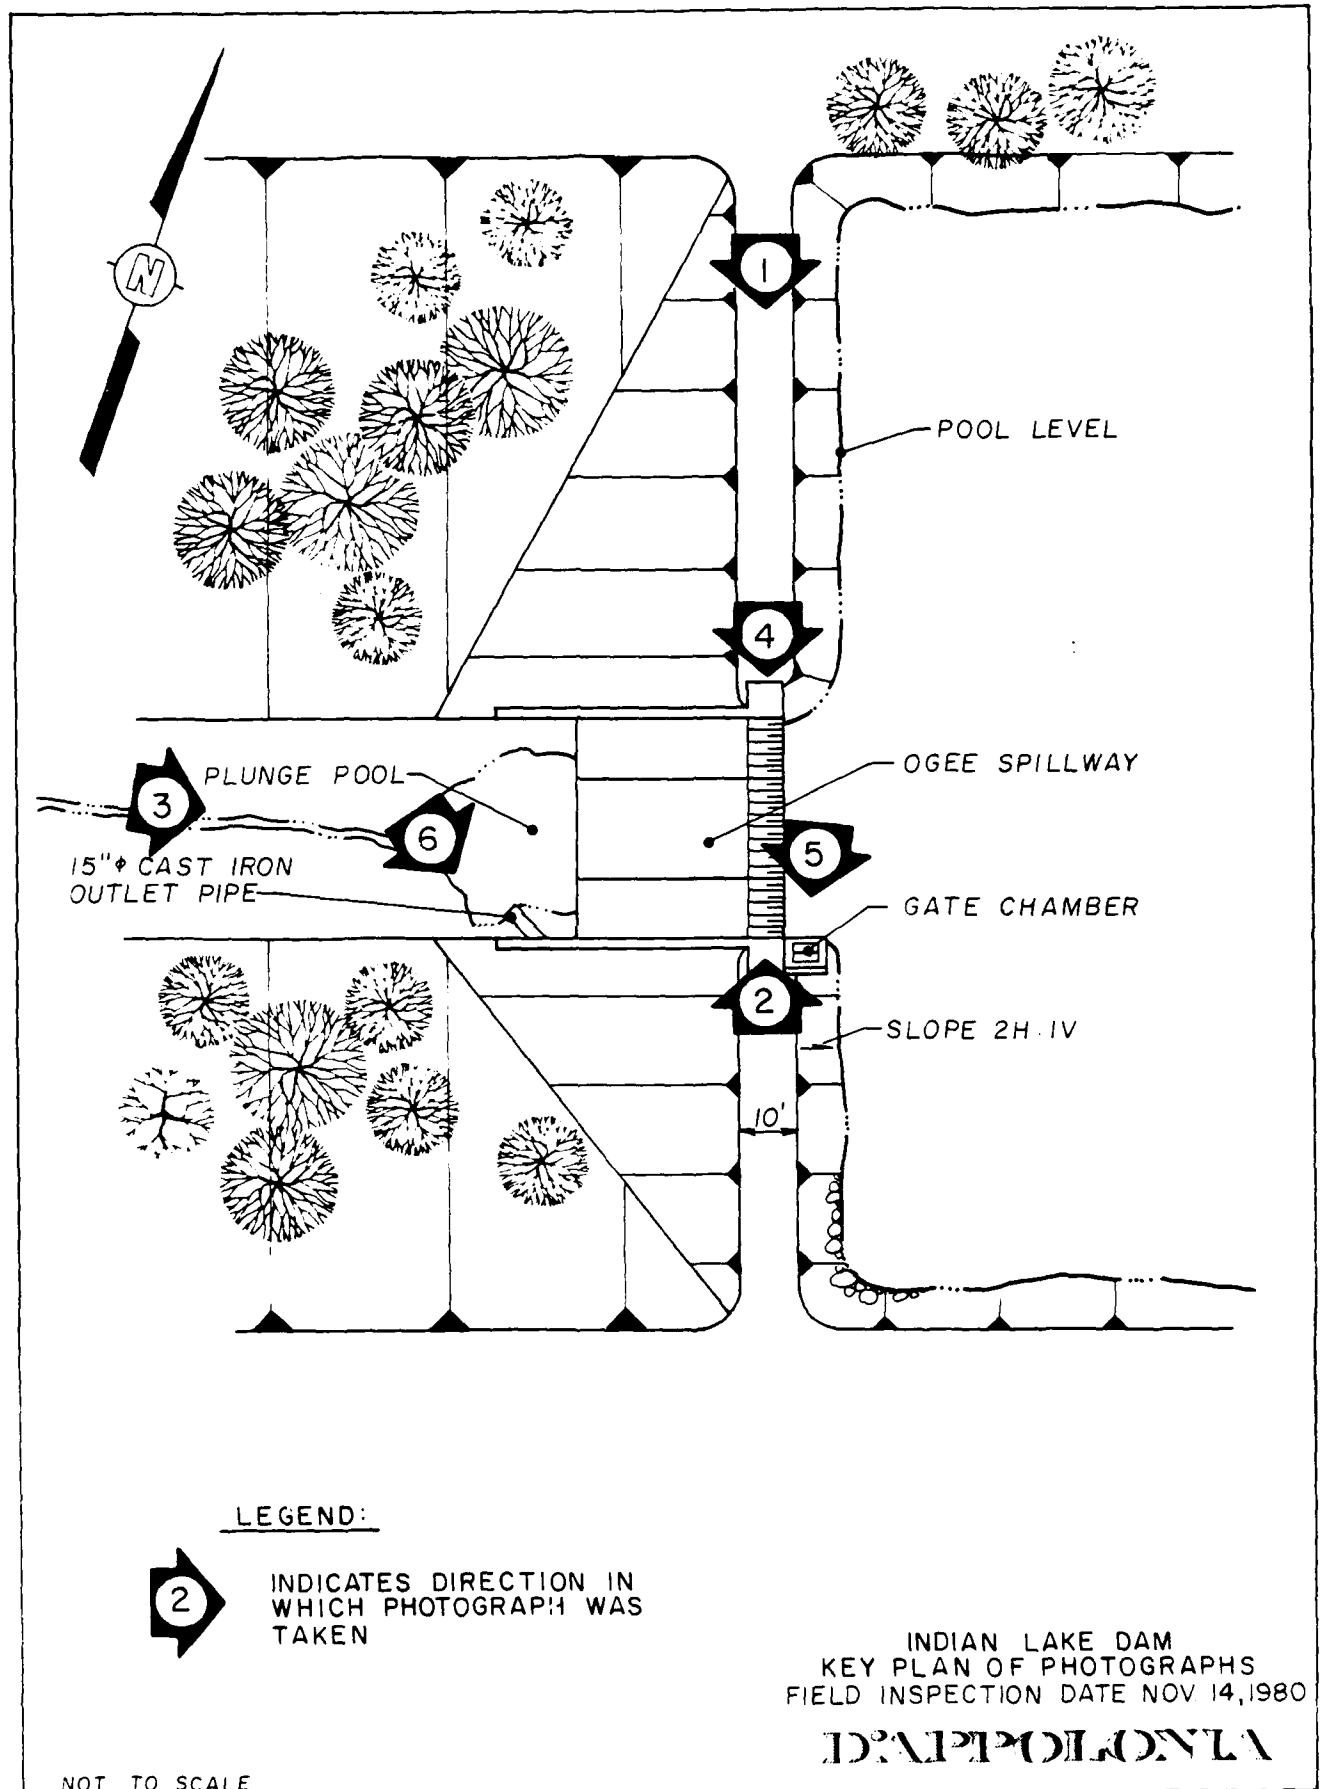
PHOTOGRAPH NO 1

<u>PHOTOGRAPH NO.</u>	<u>DESCRIPTION</u>
1	Crest (looking south).
2	Right spillway abutment.
3	Spillway (looking upstream).
4	Left spillway abutment.
5	Outlet pipe valve chamber.
6	Outlet pipe (downstream end).
7	Highway culvert (mile 0.4).
8	Trailer (mile 2.6).

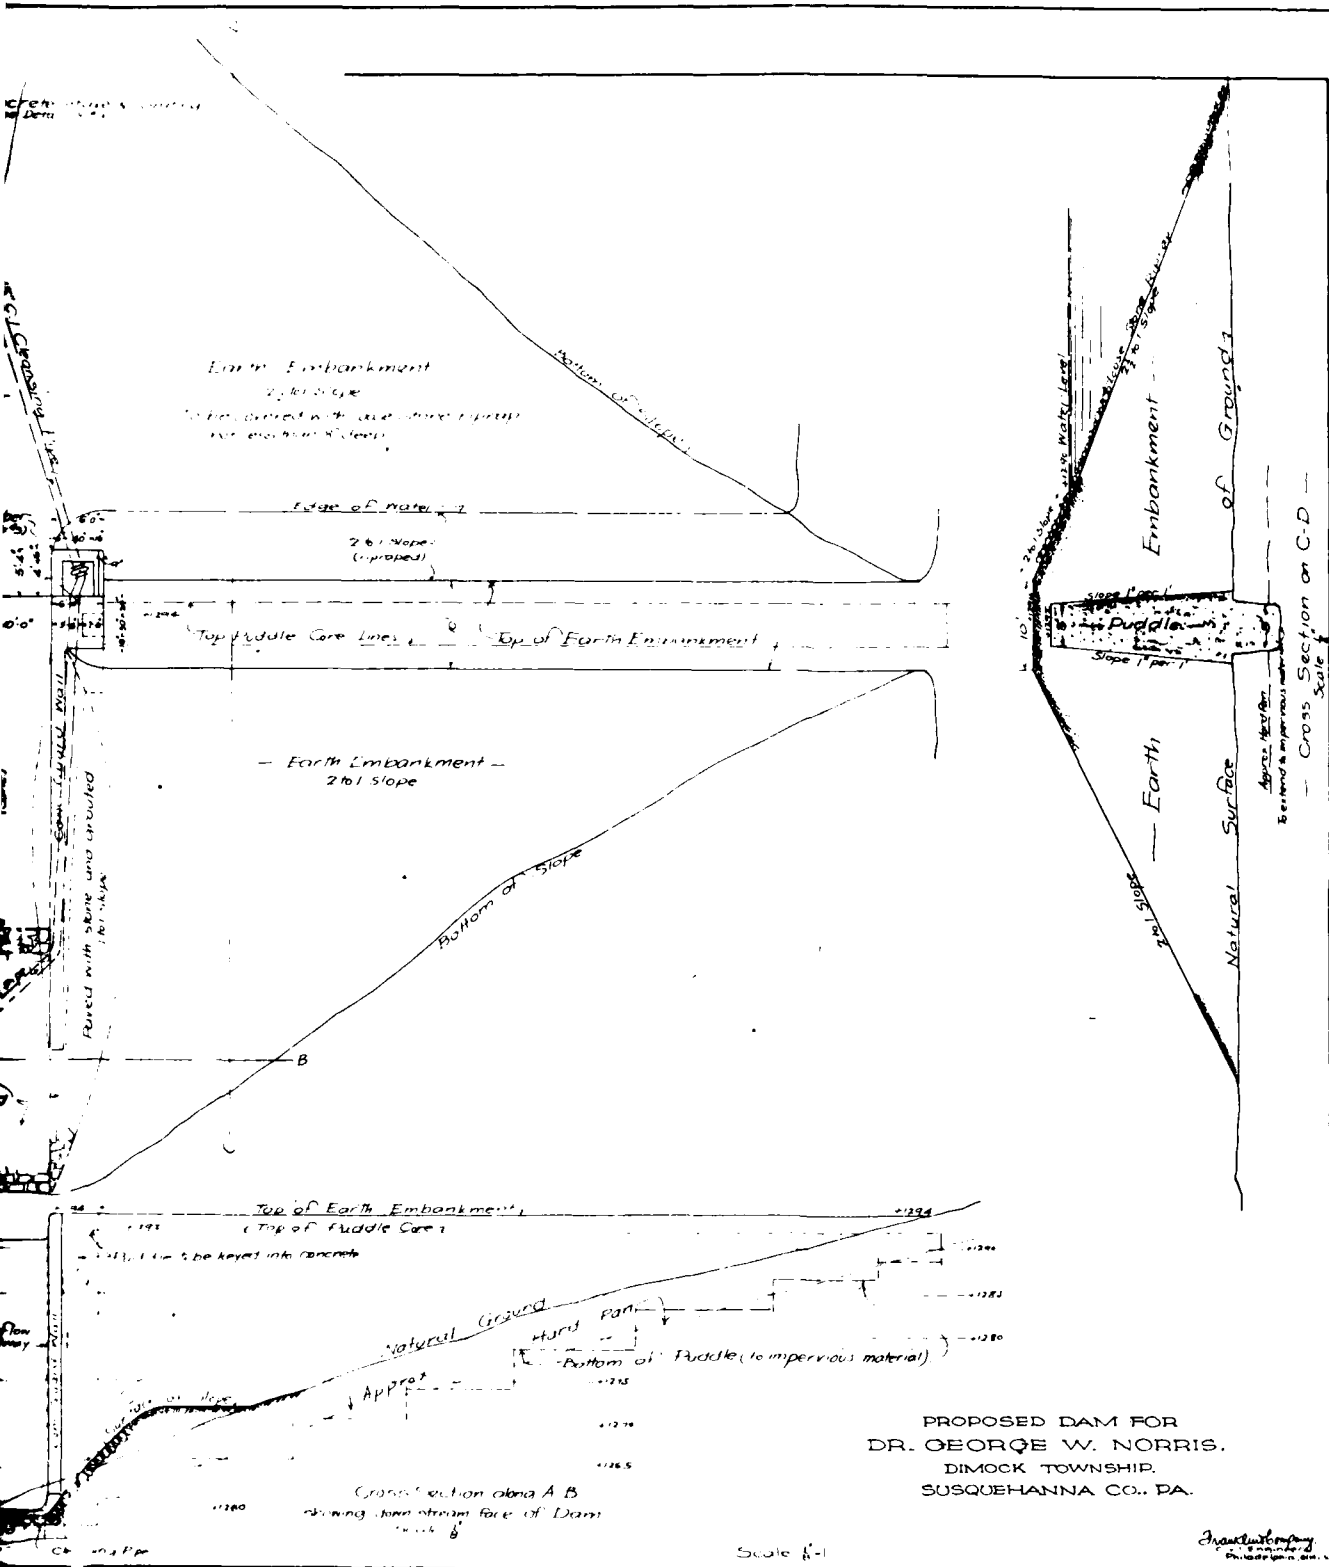
PLATE 2

in Plates 2 and 3. The overflow section of the spillway is 37 feet wide, consisting of a central 17-foot-wide low section plus two 10-foot sections on each side, one foot above the low flow section. Concrete retaining walls were built on the downstream side of the spillway to retain the earth embankment, extending to a point 14 feet downstream from the toe of the spillway chute. As shown in Plate 3, a clay fill with a slope of 1:1.5 (horizontal to vertical) was placed on the upstream side of the concrete spillway. The spillway foundation is shown to be four to five feet below the original ground surface, founded on hard pan with a two-foot curtain wall three feet deep at the downstream toe and a three-foot cutoff wall under the upstream toe extending to impervious material.

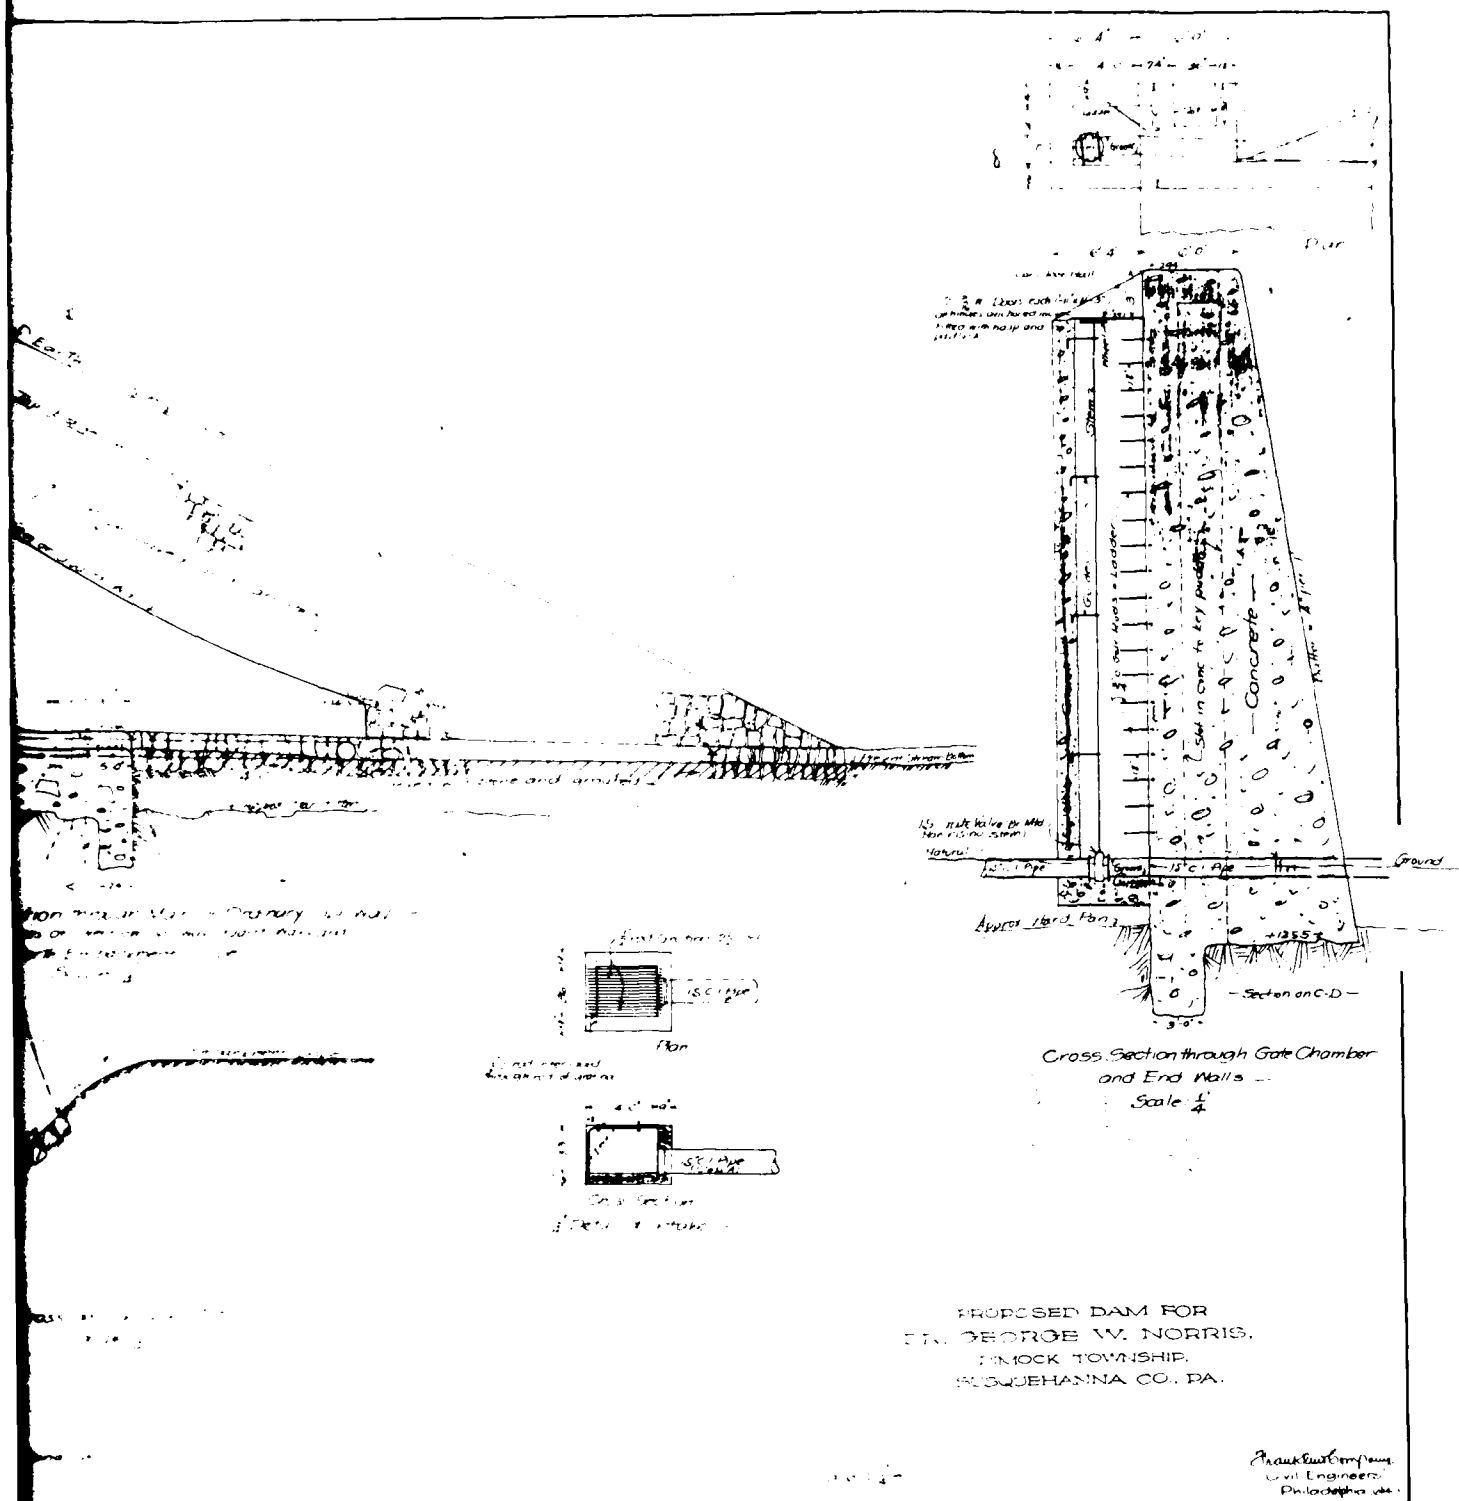
PLATE 3

The outlet works consist of a 15-inch-diameter cast iron pipe. The upstream end of the pipe is attached to a concrete intake structure protected with a grating. Flow through the pipe is controlled by a gate valve located at the left end of the spillway section which is operated by a 30-foot valve stem encased in a concrete gate chamber. Details of the outlet works are shown on Plate 3.

(3) Appurtenant Structures. Review of the design drawings indicates that, as designed, no significant deficiencies exist that should affect the overall performance of the spillway. However, the operational condition of the outlet works needs to be confirmed.

3. The owner should confirm the operational condition of the outlet works and perform necessary maintenance, if found inoperative.
4. Around-the-clock surveillance should be provided during unusually heavy runoff and a formal warning system should be developed to alert the downstream residents in the event of an emergency.
5. The owner should develop a formal operating and maintenance plan for the dam, inspect the dam regularly and perform necessary maintenance.

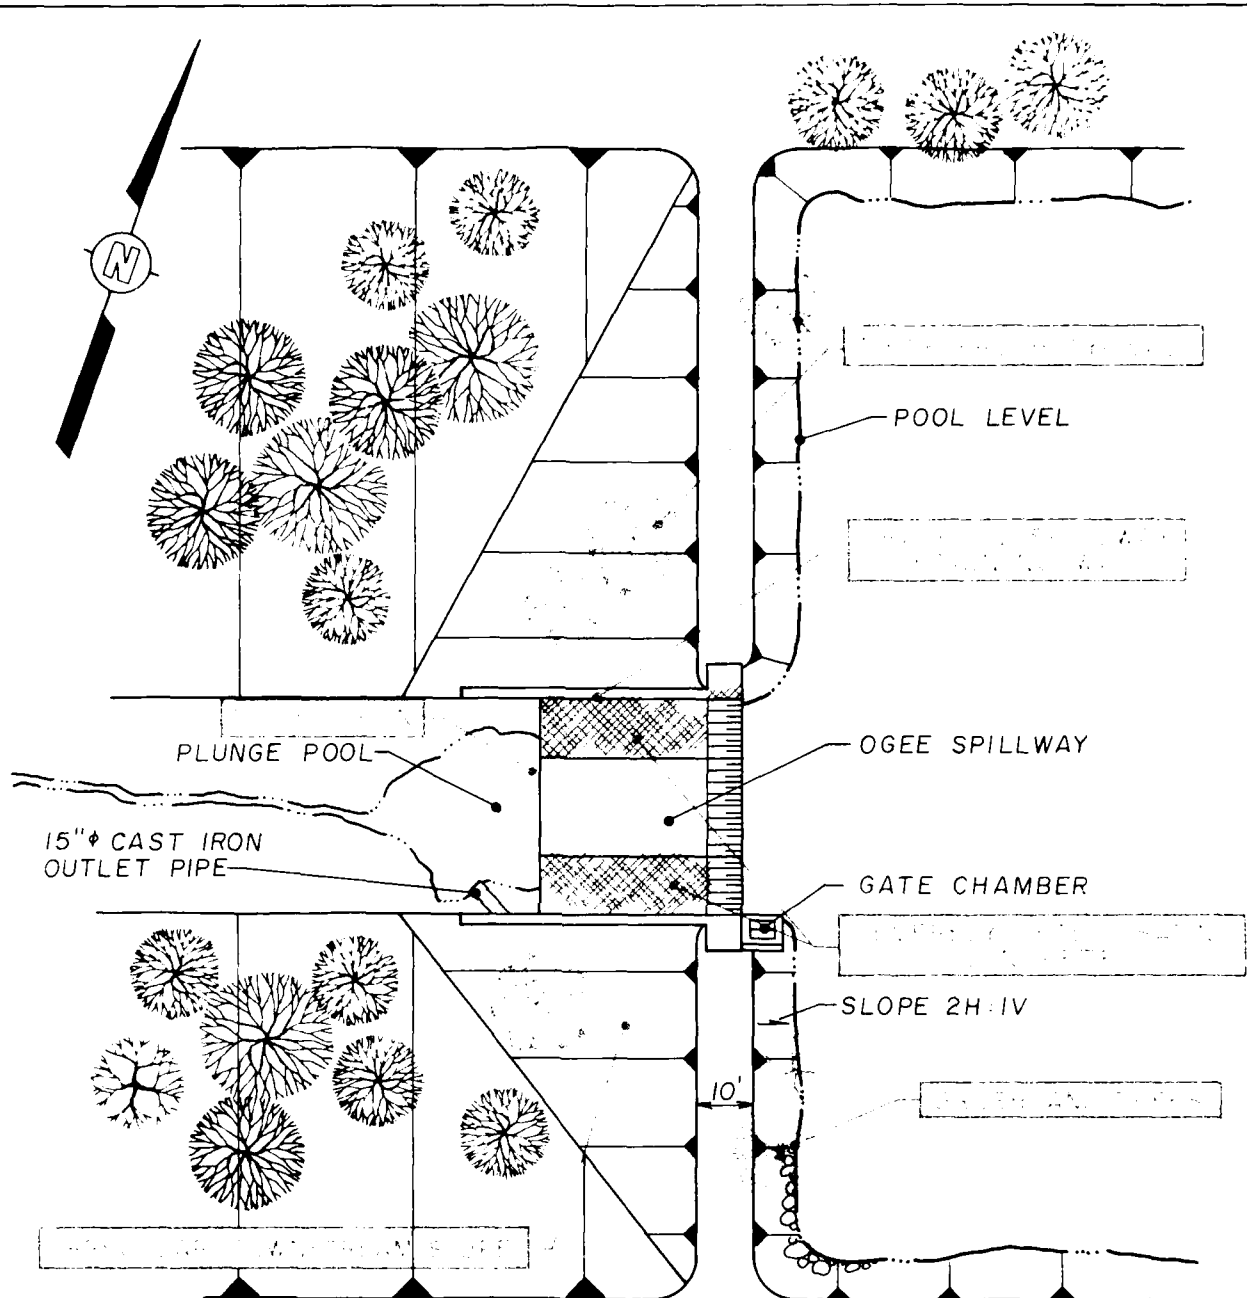
The top of the dam was surveyed relative to the spillway crest elevation and was found to have some vertical irregularities (see Plate 5). While the design freeboard for the dam was four feet, the field survey indicated a freeboard of 4.2 feet between the low spot on the left embankment and the spillway crest.

POOL LEVEL AT DATE OF INSPECTION:  
 AT LOW FLOW SPILLWAY CREST
